C-118 WEAPON SYSTEMS MANAGER

⁶ PACIFIC AREA EVALUATION OF A COMMERCIAL OMEGA

NAVIGATION SYSTEM INSTALLED IN

A VC-118 AIRCRAFT.
Supplement I.

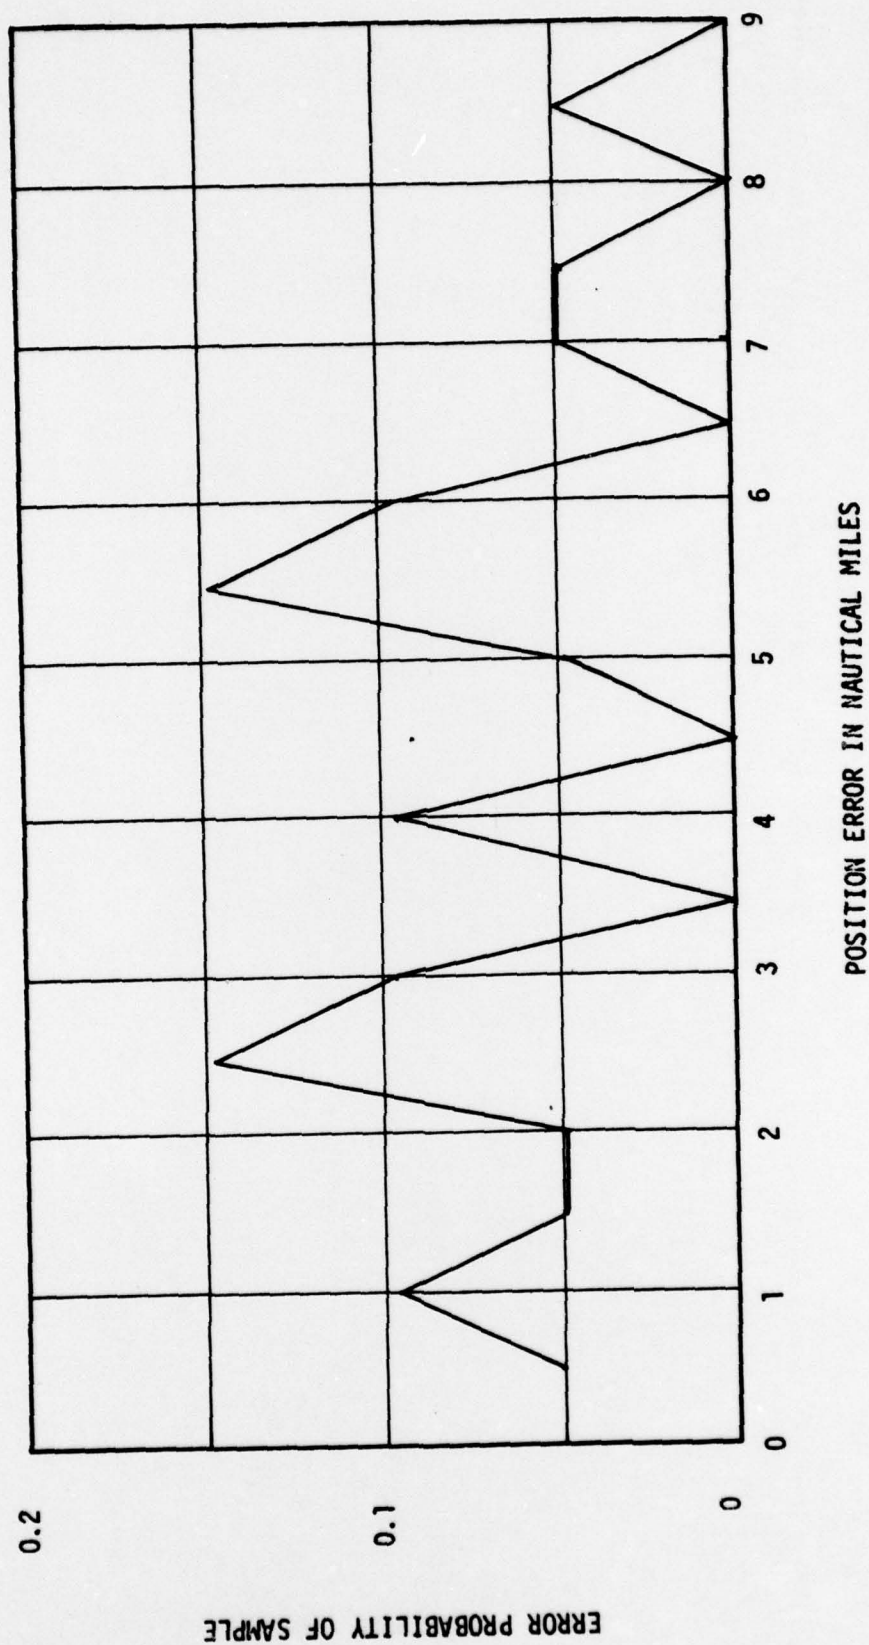
FIGURE 1. NAVIGATION ACCURACY: PROBABILITY DISTRIBUTION FOR MARK-ON-TOP DATA SAMPLE

5. The mark-on-top data points showed an average error of 3.80 nautical miles with a standard deviation of 2.280. The ONS was accurate to within 7.0 nautical miles in better than 90% of the samples, even though the TAS had not been continuously updated. The electronic/celestial data points showed an average error of 6.24 nautical miles. Additional data is found in enclosure (3).

The sample probability distribution for mark-on-top fixes is shown in figure 1 and for electronic/celestial fixes is shown in figure 2.

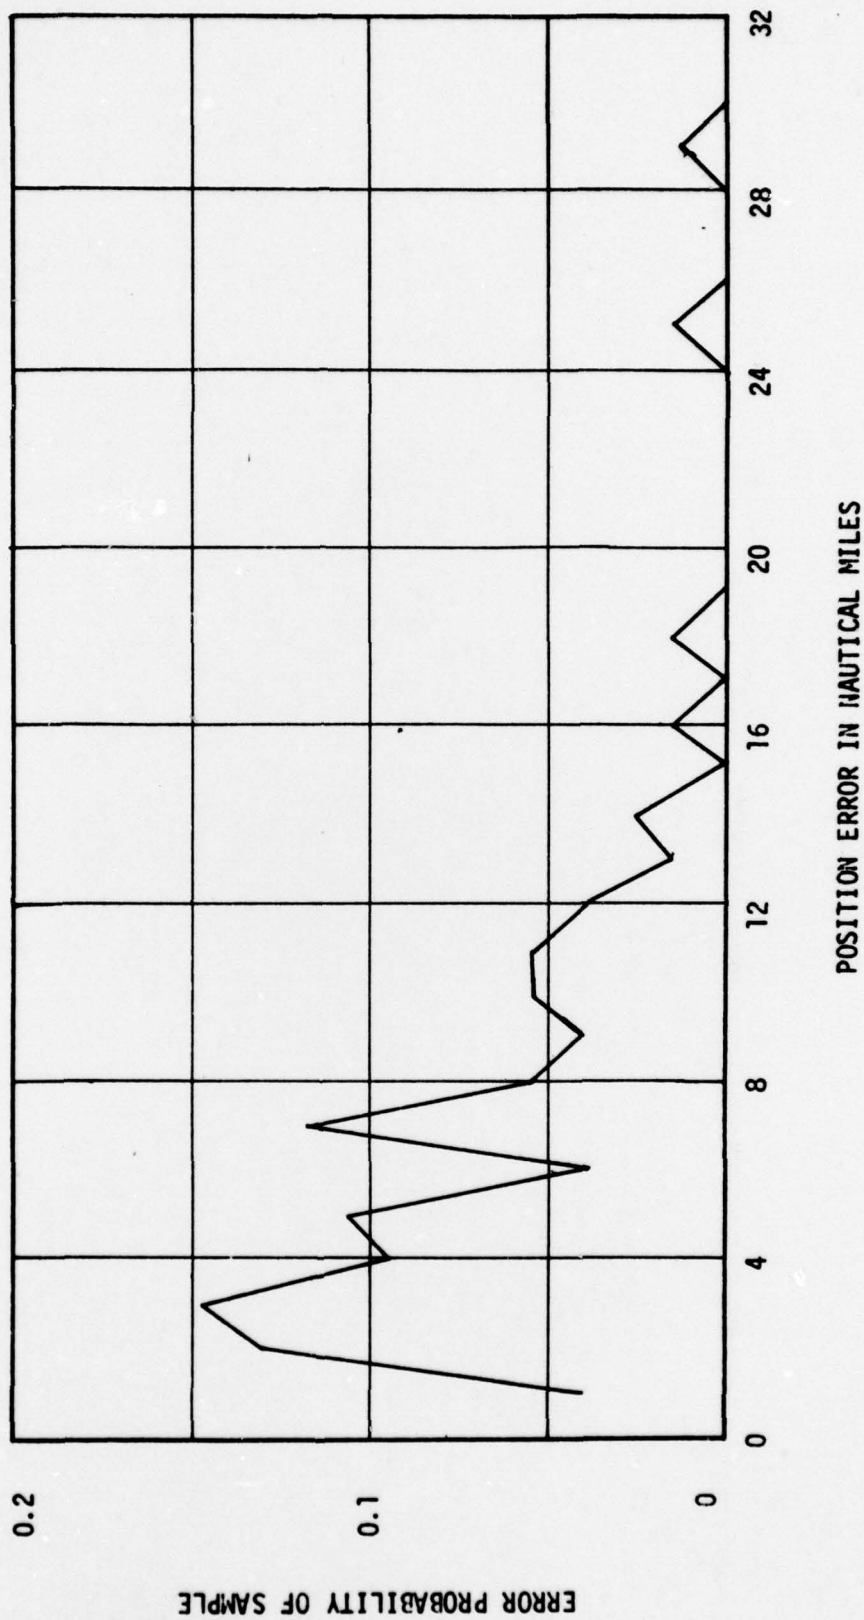
FIGURE 2. NAVIGATIONAL ACCURACY: PROBABILITY DISTRIBUTION FOR ELECTRONIC/CELESTIAL DATA SAMPLE
